TECHNICAL INSPECTION REPORT

U.S.S. MAYRANT (DD 402)

TEST BAKER

⑨ BUREAU OF SHIPS GROUP
TECHNICAL INSPECTION REPORT.

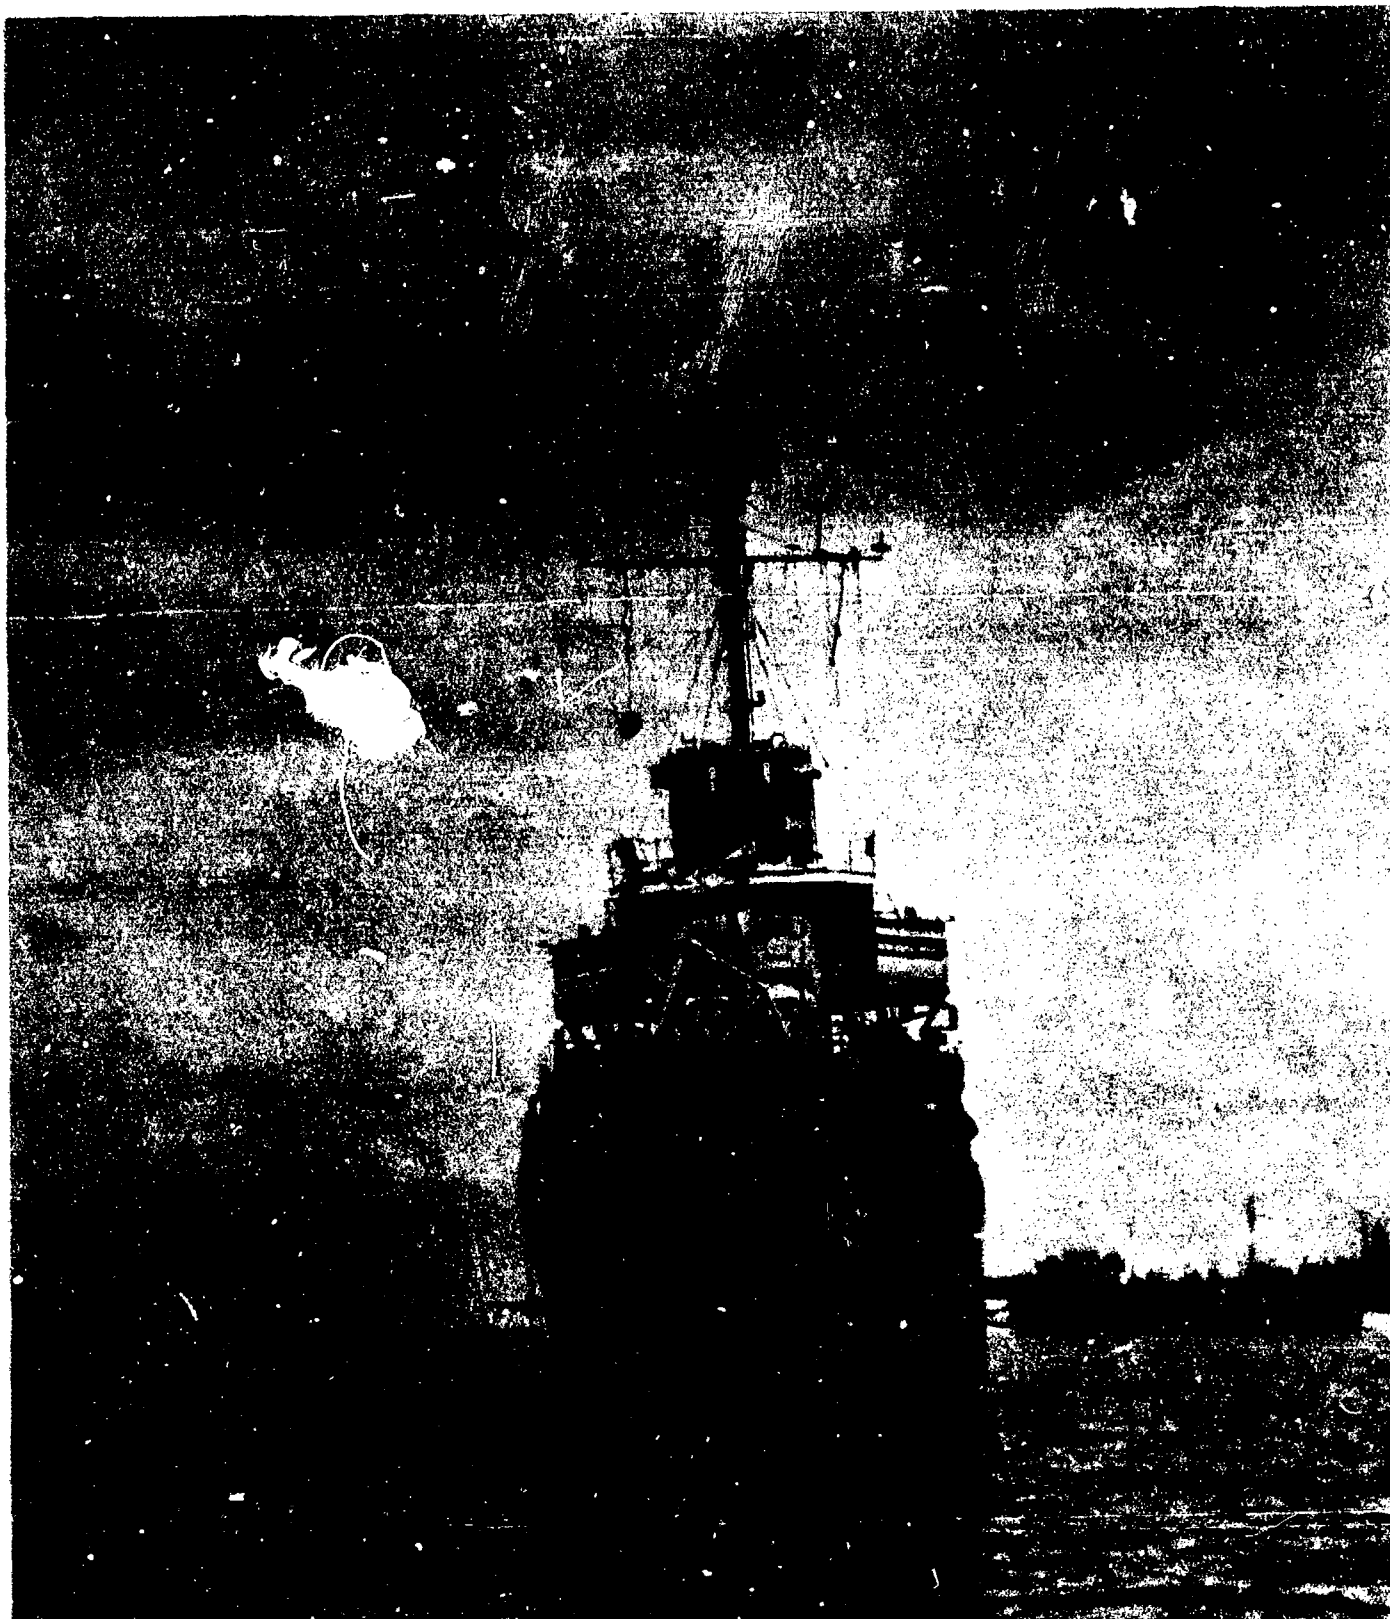
AA-CR-227-283-35. View from dead ahead after Test B.

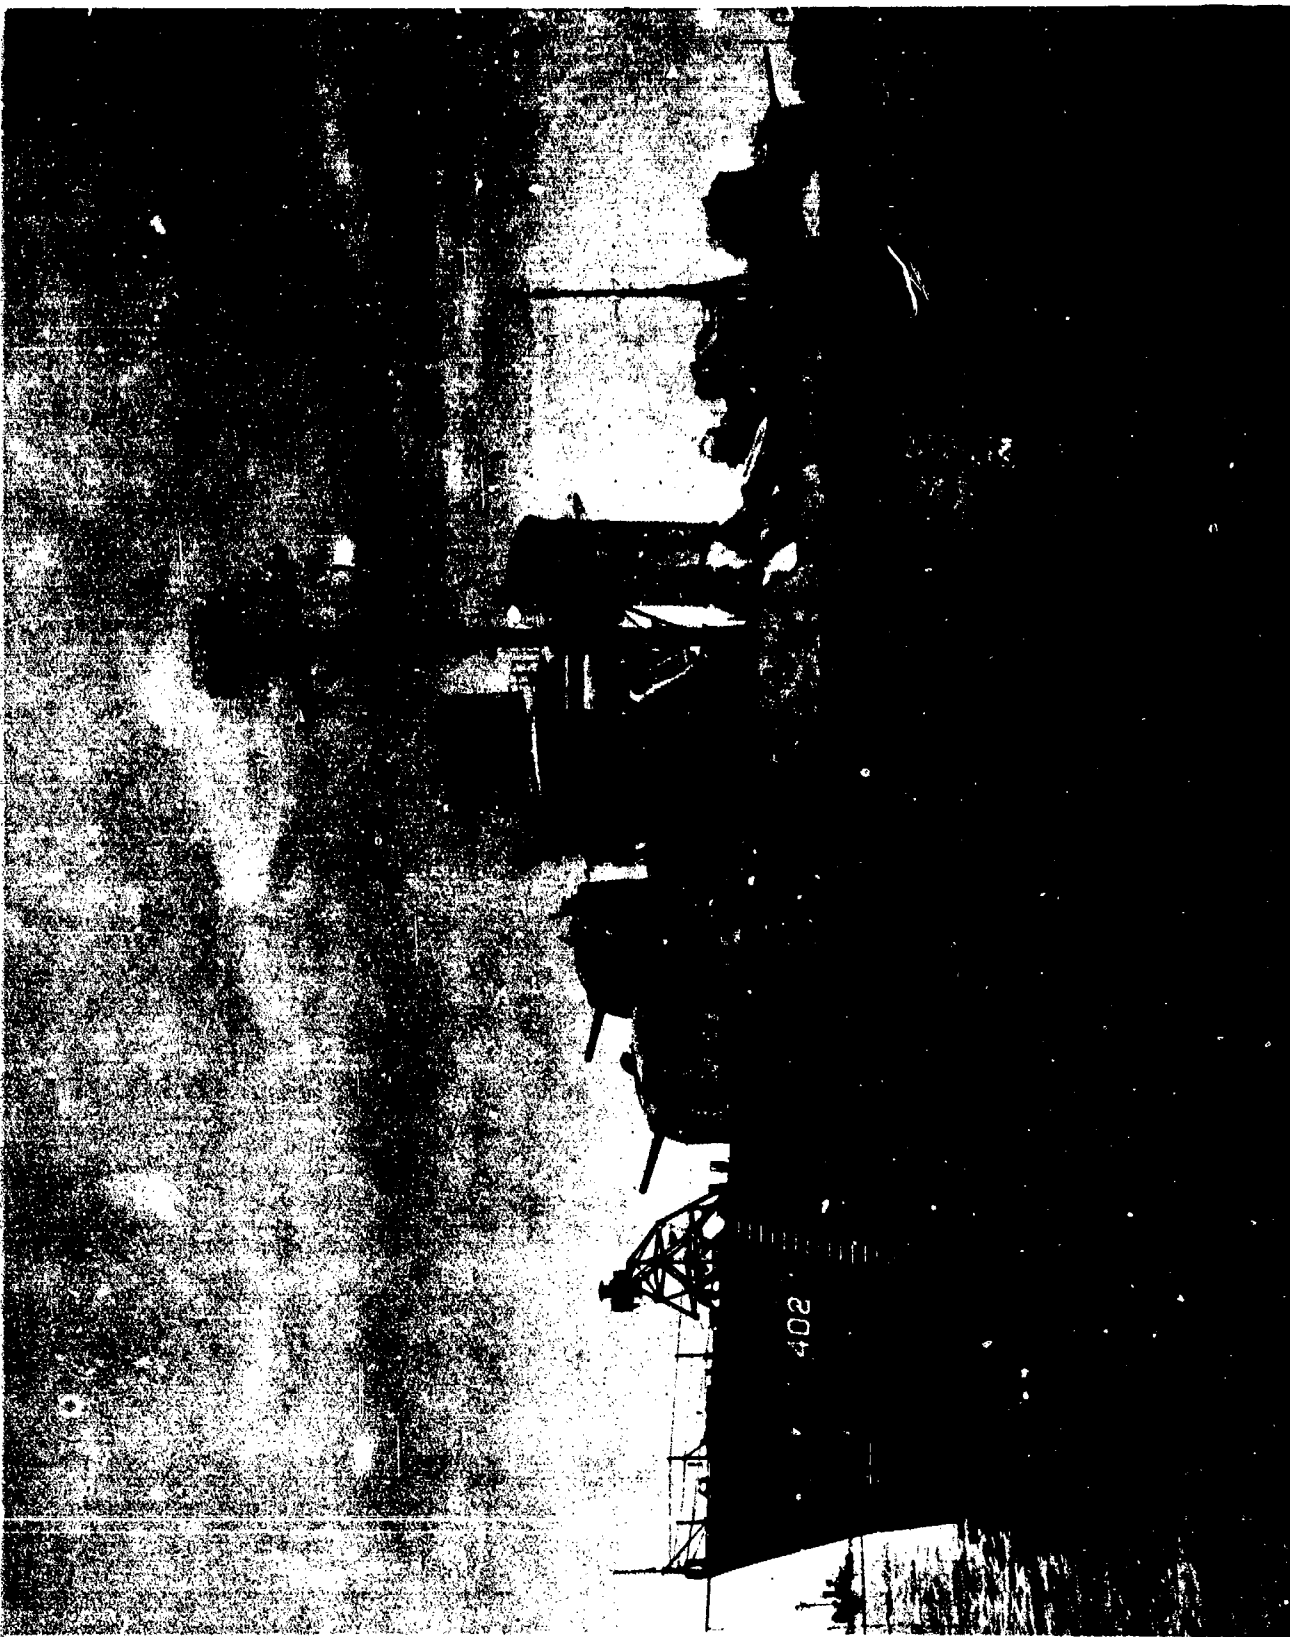
AB-CR-227-283-36. View from off port bow after Test B.

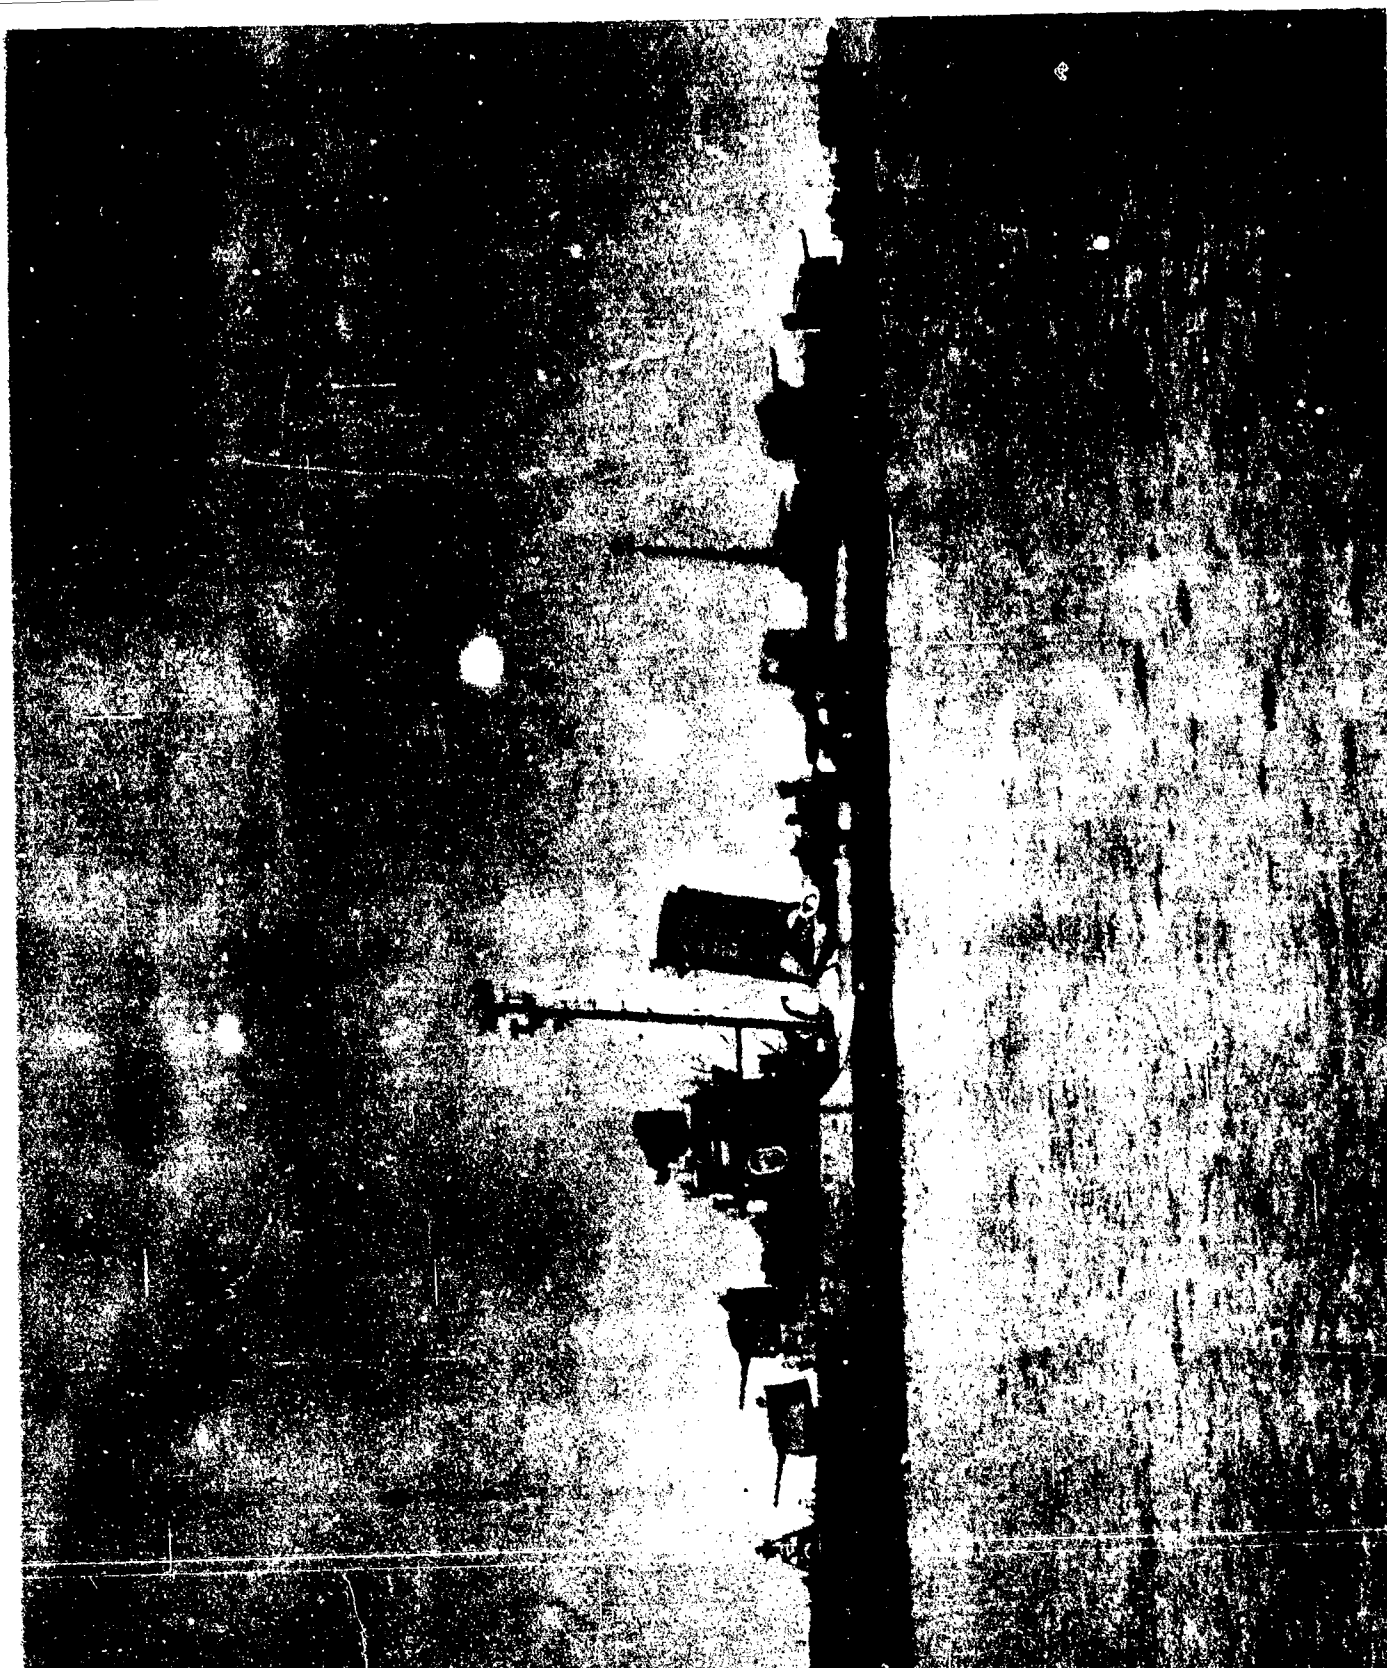
AB-CR-227-283-37. View from off port beam after Test B.

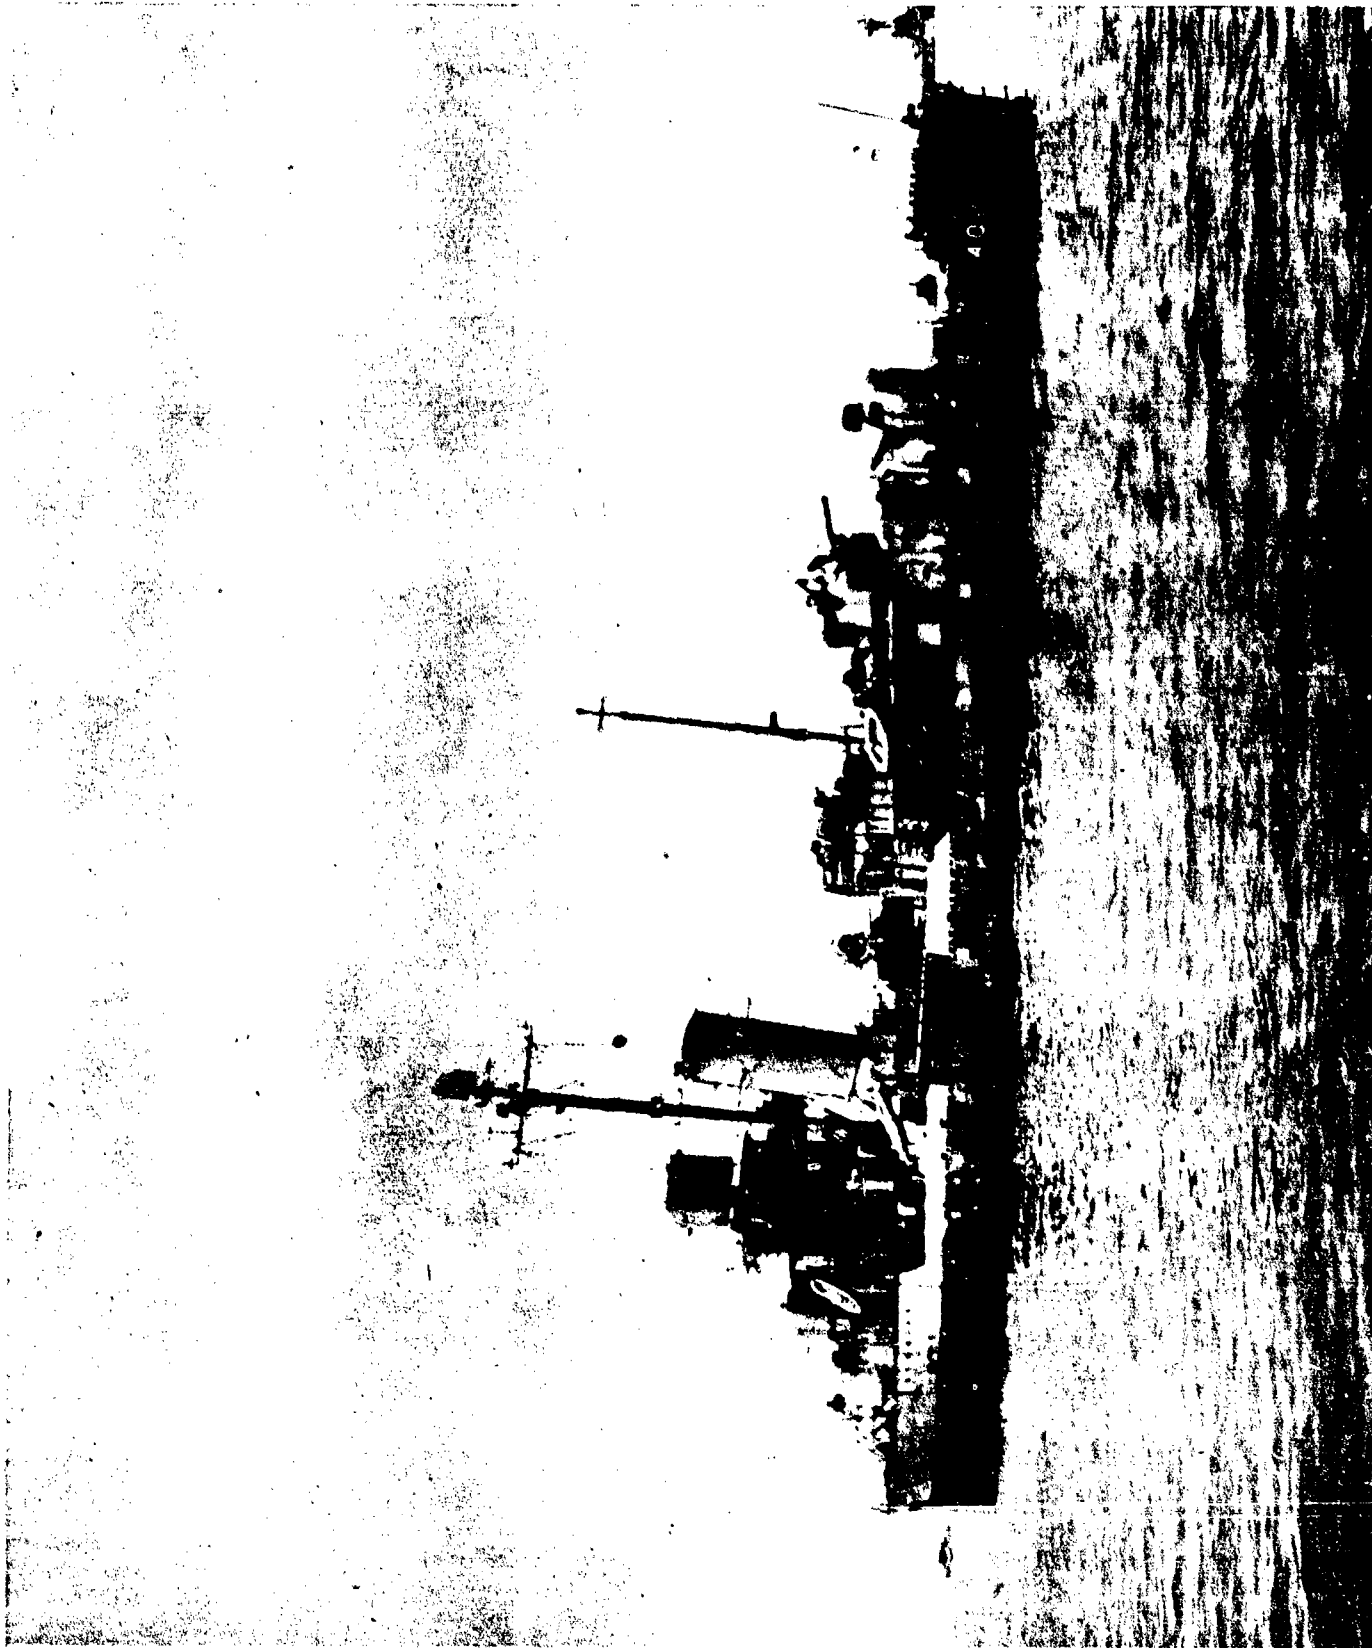
AB-CR-227-283-38. View from off port quarter after Test B.

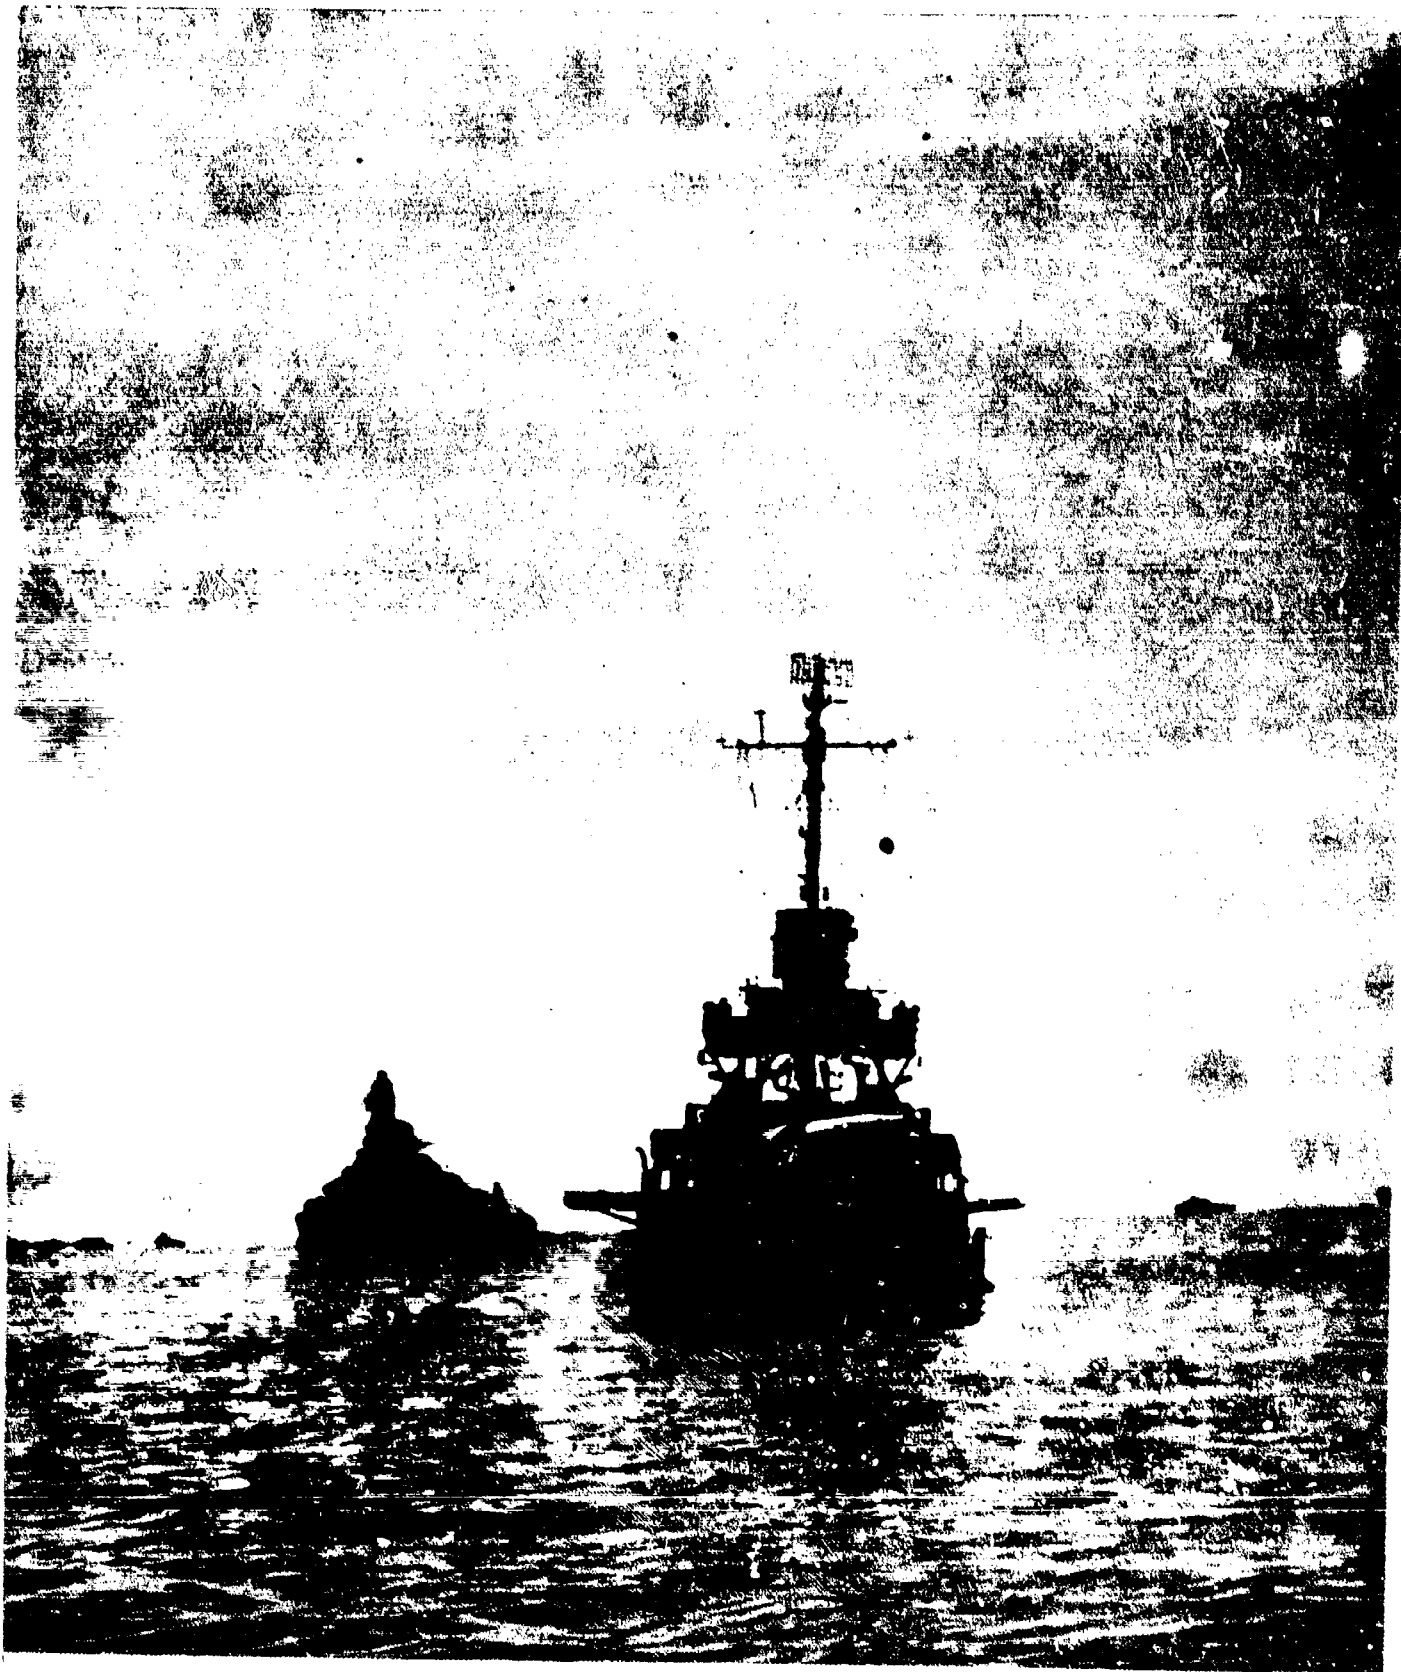
AB-CR-227-283-39. View from dead astern after Test B.

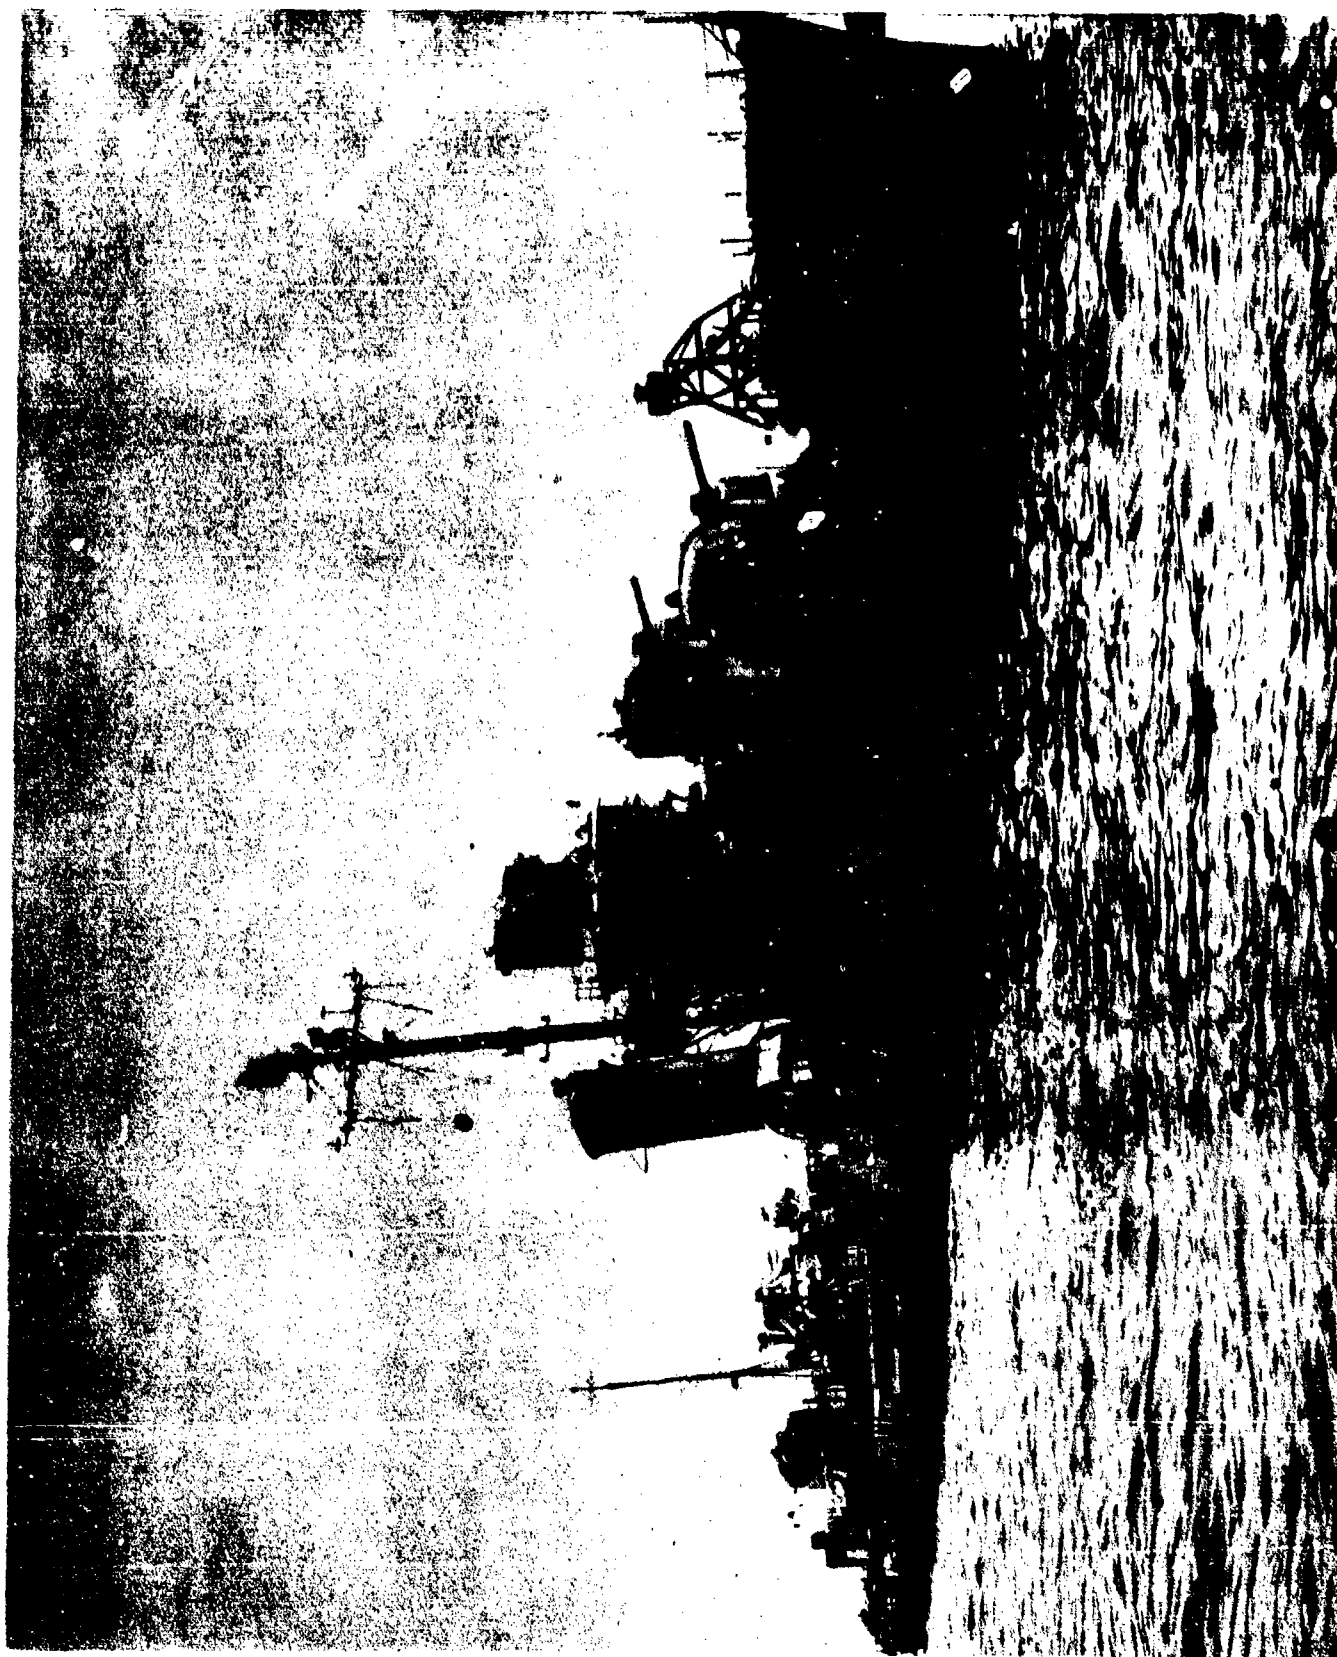
AB-CR-227-283-34. View from off starboard bow after Test B.

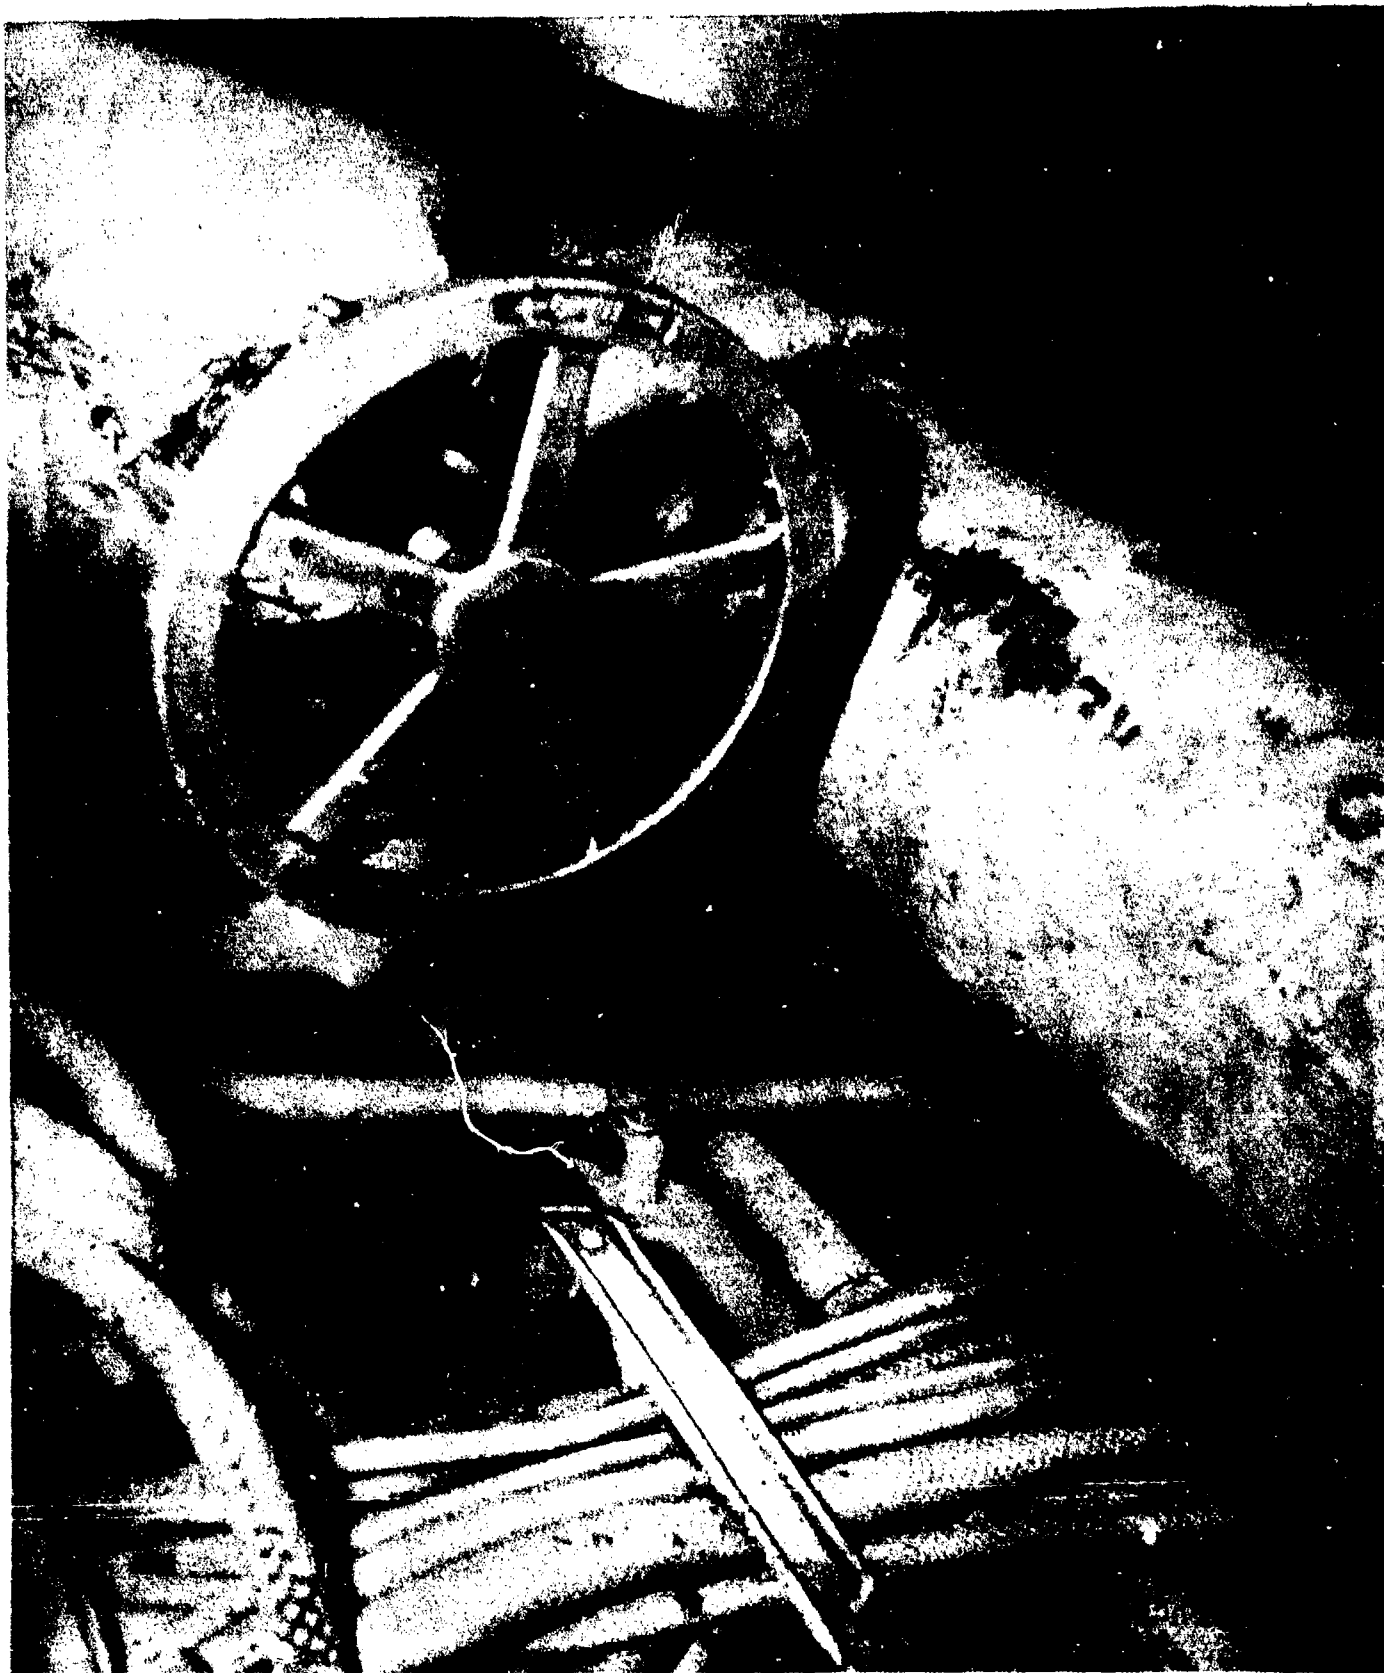
The most serious damage to interior compartments, other than radioactivity, was found in the machinery and boiler spaces. In this area the hull is dished from about 1/2 to 1 1/2 inches between frames 108 to 126. The webs of frames and the edges of transverse bulkheads are crumpled (photographs 2177-1, page 68 , 2177-2, page 69 , and 2177-3, page 70). This general dishing was apparently caused by the severe shock wave. General minor dishing of the shell occurred at frames 68 and 139, all less than 1/2 inch in depth. No other structural damage was found.

AB-CR-62-2177-2. Frame 108, starboard, looking aft at buckle in way of un-reinforced lightening hole.

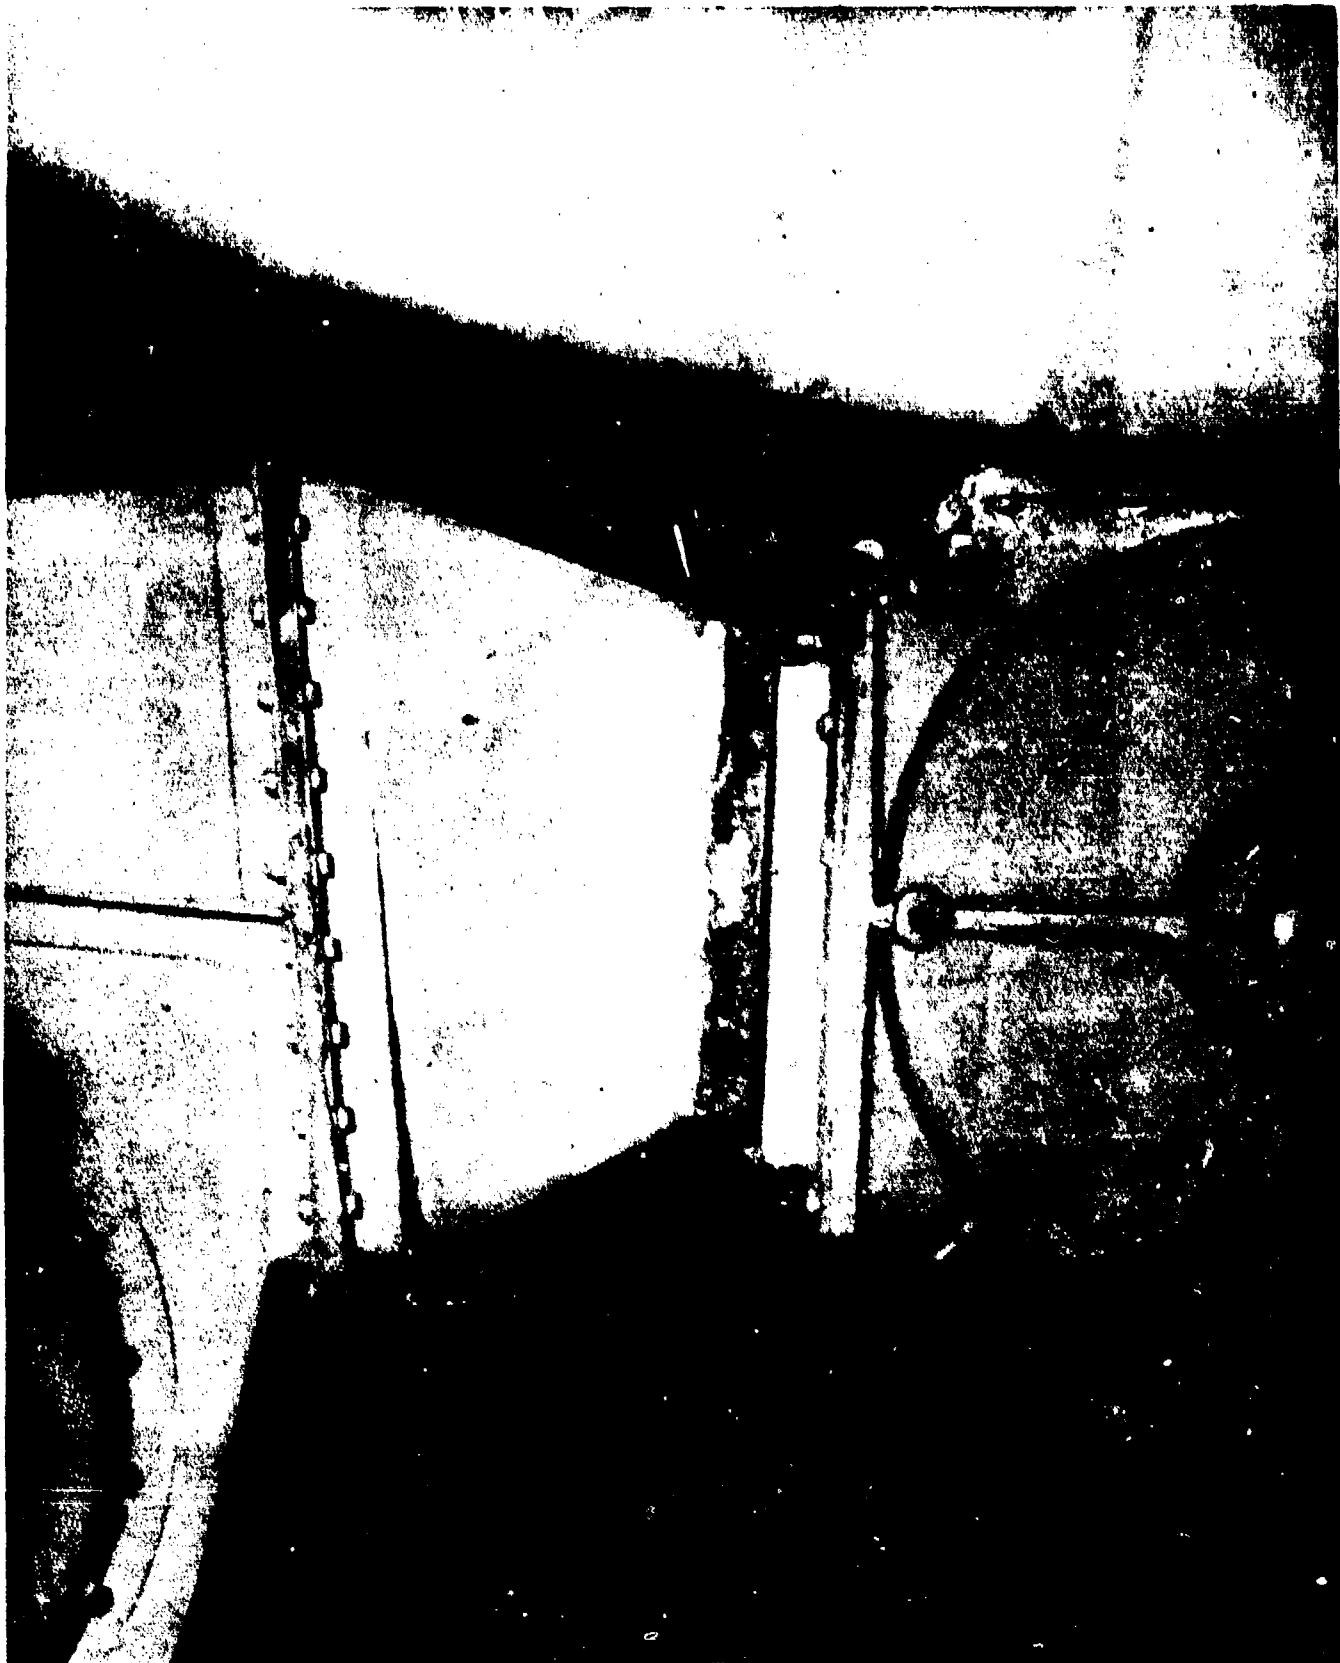
Structural damage generally was confined to the superstructure side plating, dishing of doors and starboard shell. The duct to the No. 3 port use forced draft blower in after fire room was ruptured at the section immediately below the fan outlet, however, there was no adverse effects to the motor or impeller and from visual inspection appears to be operable.

AB-CR-82-4221-4. Port use blower of No. 3 boiler.
